LAND MANAGEMENT PRACTICES OF THE ONSEN (HOT SPRINGS) INN ASSOCIATION OF URESHINO, JAPAN

Shoichiro Anai

Keywords: hot springs town, Japanese inn association, land use management, out-of-business inns, urban revitalization

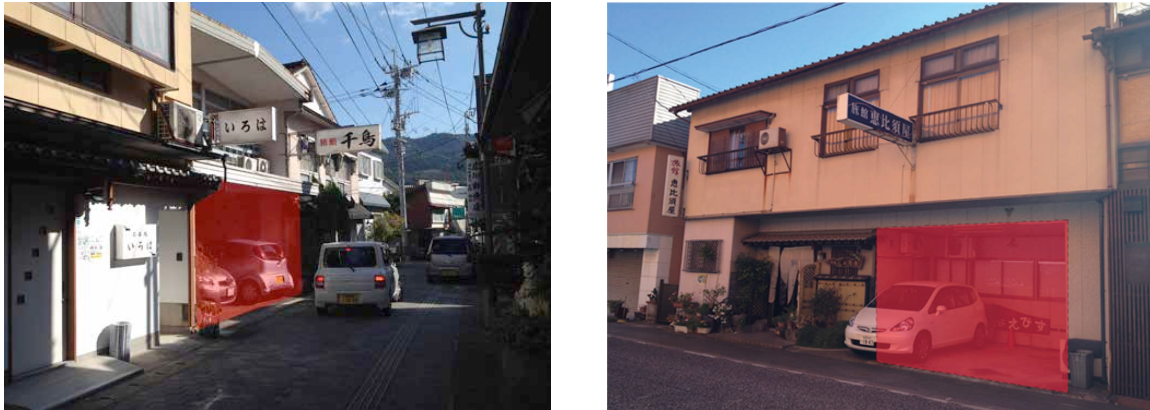
Figure 3: Examples of parking lots excluded from this research.

In our research, the term “related facilities” refers to parking lots, shops, and employee dormitories owned by local inns. We have excluded parking lots situated in the bottoms of inn buildings (see Figure 3), restricting our investigation to parking lots with their own foundation or ground space.

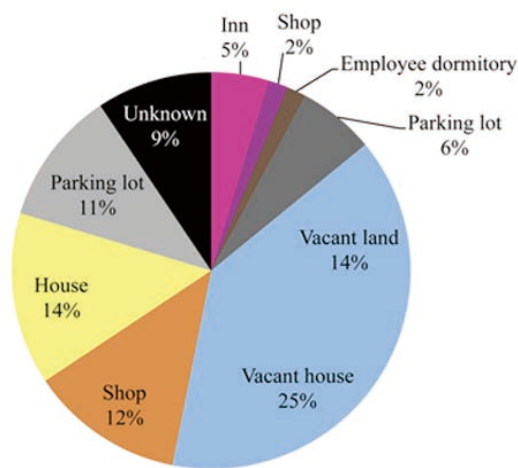
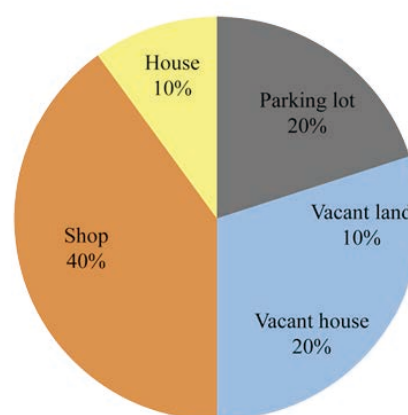
Figure 5: Current use of land vacated by out-of-business inns, reflecting differences between UIA members and non-members.

In this section, we analyze the current use of land belonging to inns that had gone out of business and compare differences between UIA members and non-members. Our investigation yielded two key differences. 1) Although several lots vacated by failed UIA member inns were converted into other inns or related facilities, no UIA non-member inns were converted into effective facilities. 2) About 30-40% of vacant land was left unused in the town, distributed between members and non-members.

The analysis in this section yielded several results regarding the use of land vacated by failed inns. First, comparing the results by UIA membership revealed that UIA member facilities were mostly converted into new uses, while non-member facilities generally were not. Comparing the results by opening date of the failed inns revealed that land belonging to inns opened after 1975 was less likely to be managed after the inns' demise than land belonging to failed inns that opened before 1975.

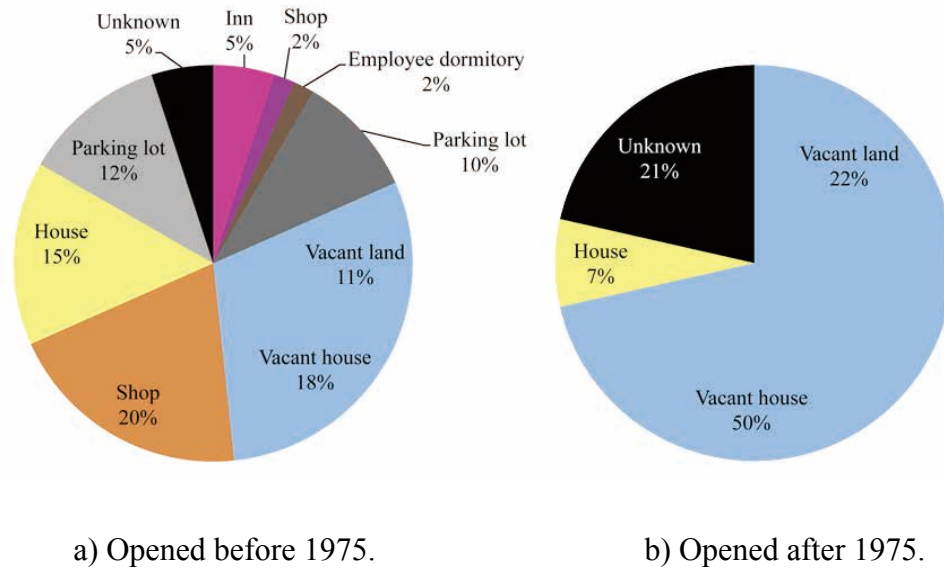
Figure 6: Current use of land vacated by out-of-business inns, comparing inns opened before and after 1975.

In this section, we analyze current uses of land belonging to inns that went out of business based on whether they opened before or after 1975. Our results were as follows. 1) Most inns that opened after 1975 were not converted to effective new uses, instead remaining as vacant land, vacant houses, or other buildings. 2) Vacant land and buildings accounted for 70% of the whole.

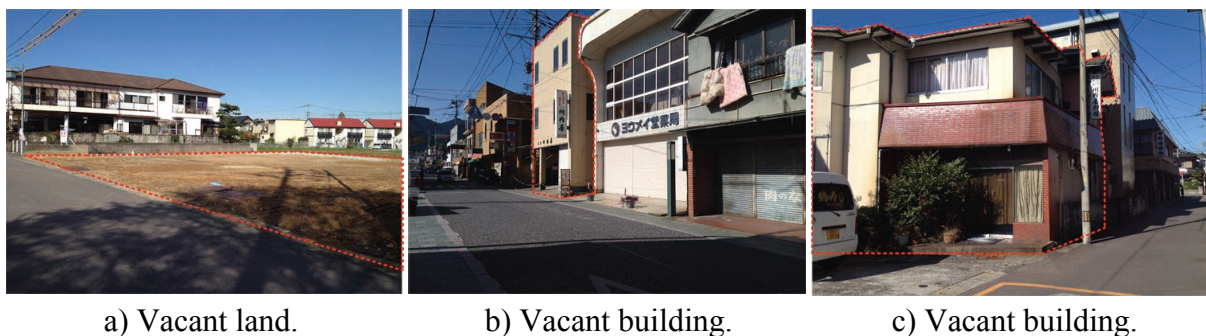
Figure 7: Vacant land and buildings owned by out-of-business-inns.

These findings suggest that vacant land and buildings should be properly managed to ensure continued use. Not only would effective management help minimize economic loss, it would prevent vacant properties adversely affecting the town's landscape and visual aesthetic.
